# BOEING COMMERCIAL AIRPLANES

## FLIGHT OPERATIONS TECHNICAL BULLETIN

**SUBJECT:** Ice Crystal Icing

**APPLIES TO:** 737, 747, 757, 767, 777, 787

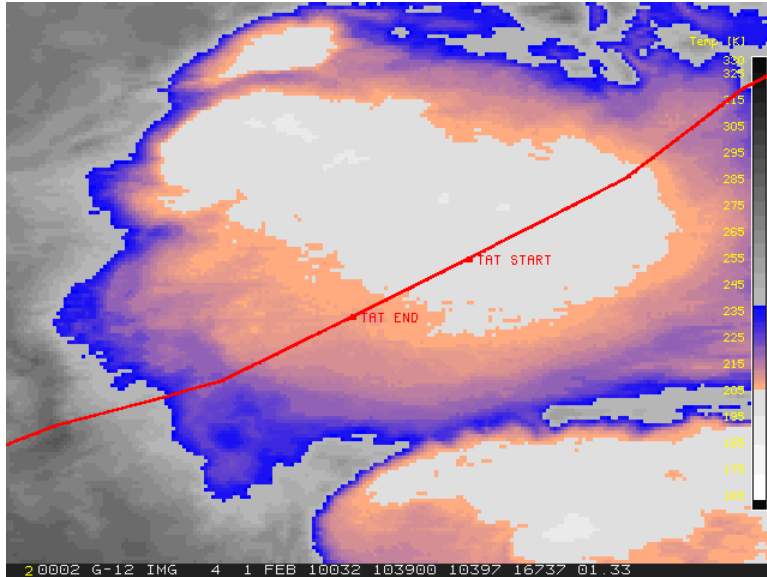
Infrared cloud top temperatures were measured and recorded for each event location. As a result of the analysis, the median cloud top temperature was found to be -63C, the middle half of events had cloud top

temperatures ranging from -55 C to -70 C, the maximum temperature was -44 C, and the minimum was -87 C

**Figure A:** Enhanced infra-red satellite image showing clouds at or above the tropopause in grey and white colors. The airplane track is shown in red. An engine damage event occurred during a TAT anomaly, noted by TAT start and TAT end notations. In the flight deck, the flight crew observed an auto-throttle disconnect associated with the TAT anomaly.

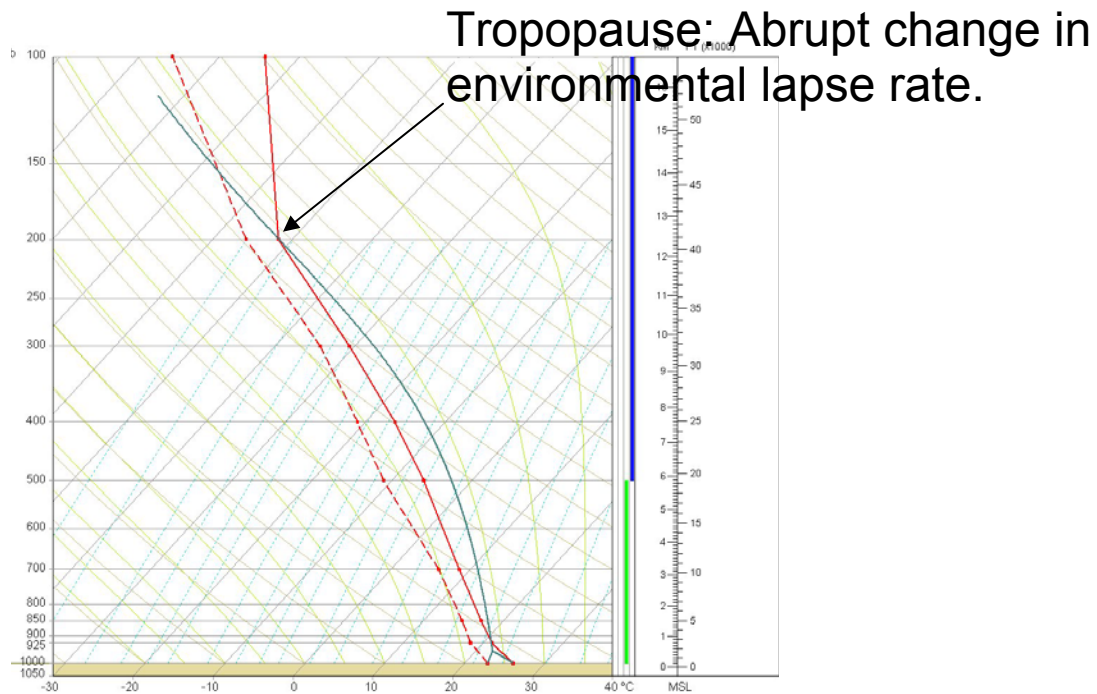
**Figure B:** An average sounding compiled from engine power loss and damage events up through 2009

A study of environmental parameters indicates engine events occur with moderate instability (median CAPE of 1,141 J/kg & median lifted index of -3.7), high moisture (median precipitable water of 2.3") The highest risk areas will be MCS's that occur within an environment that has PW values of 2" or greater.
