# BOEING COMMERCIAL AIRPLANES

## FLIGHT OPERATIONS TECHNICAL BULLETIN

**SUBJECT:** Ice Crystal Icing

**APPLIES TO:** 737, 747, 757, 767, 777, 787

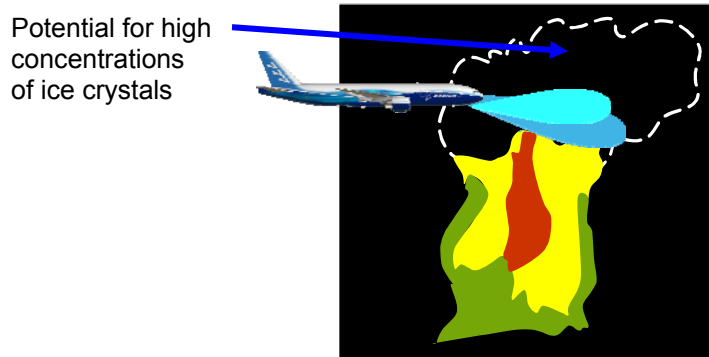
### 3.3 Heavy weather radar returns below flight level

- From event weather radar analysis, events consistently occur when the aircraft is in Instrument Meteorological Conditions (**IMC**) and **over-flying an area which would be amber or red** on the pilot's weather radar. Ice that has been lifted to high altitude eventually falls through the freezing level and begins to melt. These wet particles are much more reflective and therefore visible (amber or red) to radar. These clouds can be identified by pilots if they **manually tilt the radar down** to scan below the freezing level.
